## FG MKII ICC REMOVAL

## **TERRITORY SZ ICC REMOVAL**

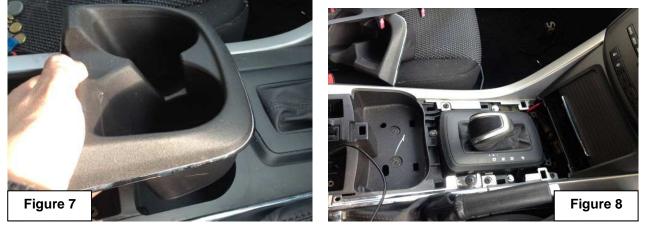
5. Remove the 2 rubber bases from the bottom of the drink holders and remove the screws and pull out the drink holder. Refer figure 7. Remove the surround from around the gear shifter. Refer figure 8.
