PROCEDURE TO REMOVE BARRA ICC

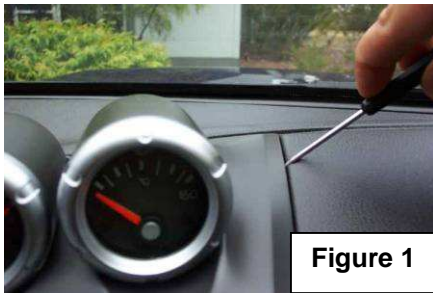
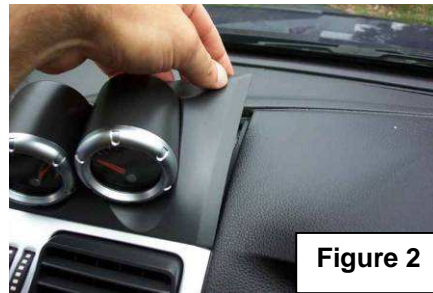
1. Battery Disconnect GND lead from.
2. While being careful use a plastic removal tool and lift triangle panel from top of ICC (Refer figure 1 & 2).

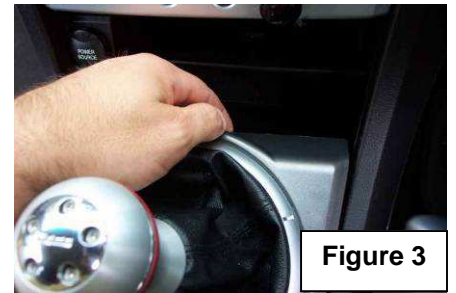
3. Using your hand pull up from the front the panel around the gear lever to remove. (Refer figure 3) If an automatic gear shift surround place in a suitable location.

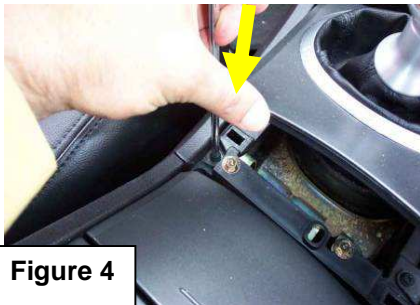
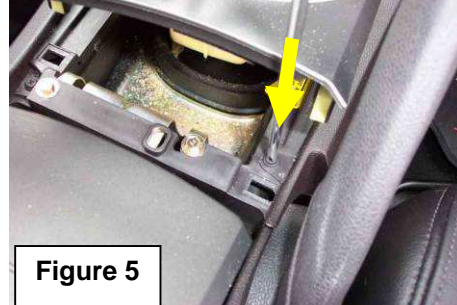
4. With a Phillips screw driver, remove 2 x screws from under the Gear lever panel for the side wings. Figure 4 & 5.

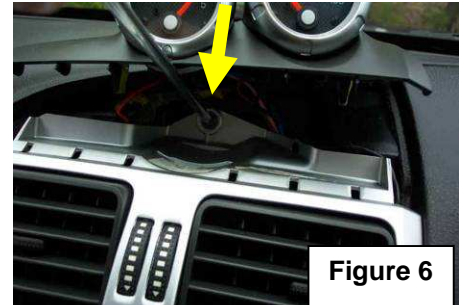
5. Also remove 1x screw from under the top panel. Refer figure 6.
6. Remove the side panels for center console as shown. Figure 7.

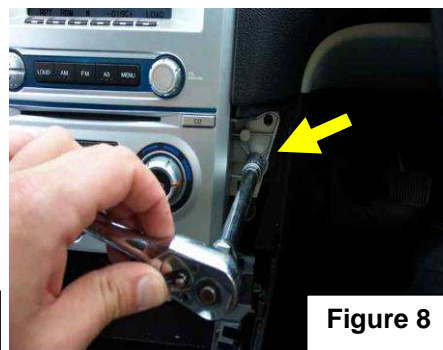
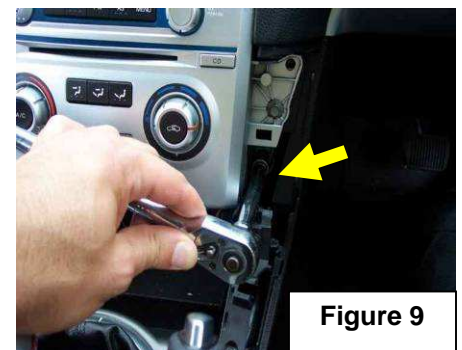
7. With a socket (8 mm) remove the 4x screws from side of ICC. 2x screws on each side. Figure 8 & 9.

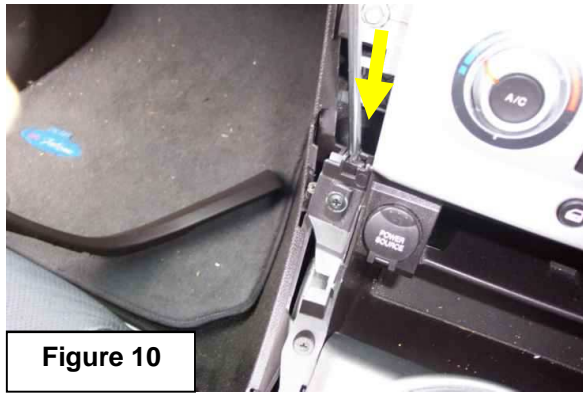
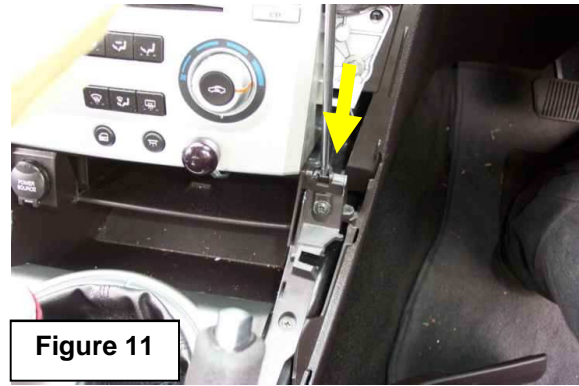
8. Remove the tissues box from under the ICC in some cases there will be a screw in each side holding in the tissue box these will need to be removed first before trying to remove the tissue box. Figure 10 & 11.
